CASE REPORTS

## Complications Associated With the Guide Wire in Percutaneous Transluminal Coronary Angioplasty

*(J Am Coll Cardiol 1987;10:218-21)*

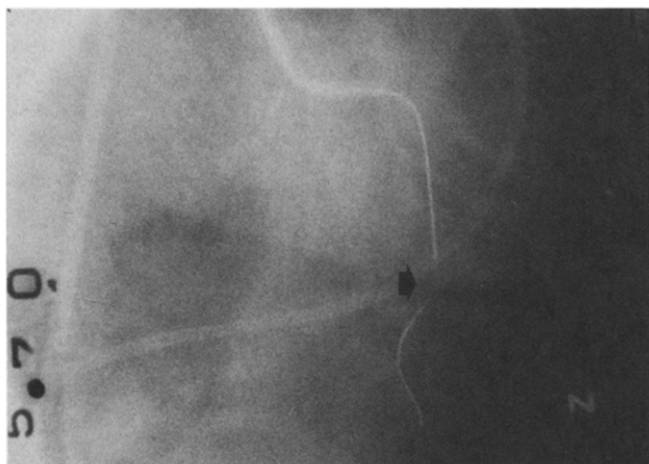
At angioplasty, the left anterior descending artery stenosis was crossed with a USCI 0.014 inch flexible J guide wire and successfully dilated with a USCI 2.5 mm balloon. To enter the circumflex artery it was necessary to manually increase the distal angle of the J guide wire. This permitted successful entry into the circumflex artery and its third obtuse marginal branch. The lesion was crossed with the wire and the balloon advanced into the narrowed segment. However, just before balloon inflation, it was noted that there was a translucent segment in the spring coil suggesting a break (Fig. 1). The lesion was successfully dilated and then the balloon catheter and guide wire were simultaneously removed as a unit. Direct inspection showed that the coiled platinum wire on the steel core had become unraveled 2 cm from the tip, thus accounting for the appearance of radiolucency on fluoroscopy.

**Figure 1.** Case 1. Right anterior oblique projection. The guide wire is in the circumflex artery with the tip in a third obtuse marginal branch beyond the stenosis. The **arrow** indicates a segment of translucency in the wire, presumably due to unraveling of the platinum coil.

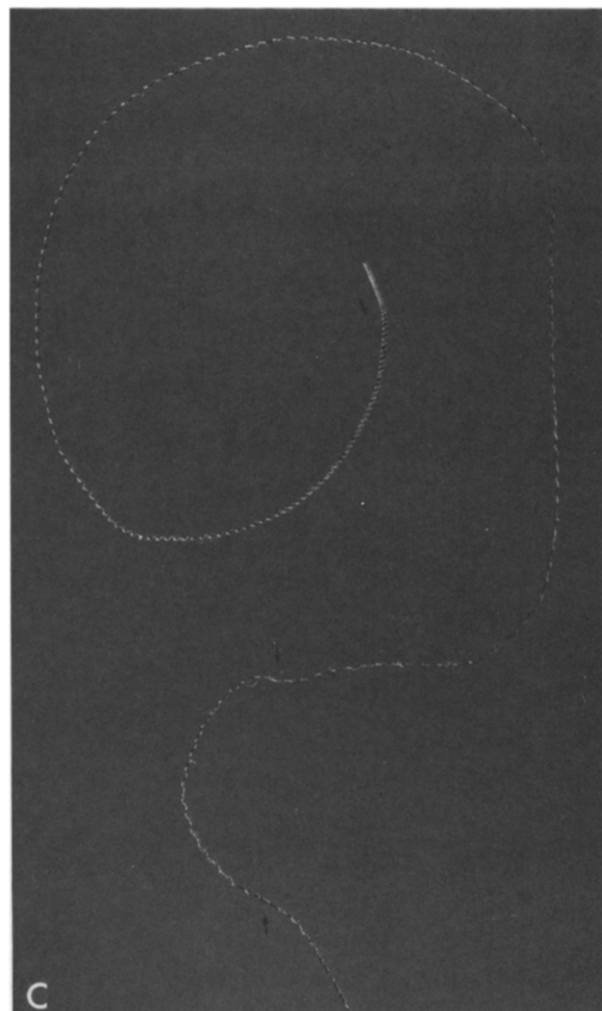
tomosis of the right bypass graft and an 80% stenosis in the proximal posterior descending branch (Fig. 2A).

*removed*, it was noted that the distal 3 mm were intact but proximal to this point the single platinum coil had become unraveled (Fig. 2C). It was also observed that the forming ribbon had become detached from the distal tip weld. The end of the forming ribbon and the distal solder joint are shown in Figure 3.

**Figure 2.** Case 2. **A**, Right anterior oblique projection of an angiogram of the right bypass graft and the ongoing right coronary artery showing a significant stenosis (**arrow**) in the posterior descending branch. **B**, A wire fragment is lodged in the posterior descending branch and the bypass graft. The distal segment has not unraveled and therefore is more radiopaque (**arrows**). **C**, The segment of wire removed surgically. The **arrow** on the top shows the point at which the unraveling of the wire began. The forming ribbon is detached from the tip (**middle arrow**). The **arrow** at the bottom of the picture shows the distal solder joint.

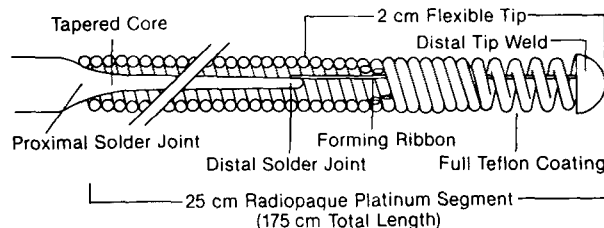
The guide wires used in our three cases were USCI 0.014 inch flexible steerable J wires (Fig. 3). The total length of the wire is 175 cm long, the distal segment of which is tapered. Wound on this tapered segment is a tightly coiled single strand platinum wire 25 cm in length which makes this segment radioopaque and provides steerability to the system. The final 2 cm extend beyond the central steel core. The platinum coil is soldered to the steel shaft at two points

at its proximal end called the proximal solder joint, and at three points more distally called the distal solder joint. A forming ribbon extends from the distal solder joint to the distal tip weld. The wire is coated throughout its length with Teflon.

**Figure 3.** The structure of the 0.014 inch flexible J guide wire used in the three cases (modified from USCI specifications).
